Flood Resiliency Report & Facilities Capital Expenditure Forecast Plan

March 8, 2018

Final Report

H. T. McGrath Jr. FAIA-FAPT, Principal McGrath Architecture

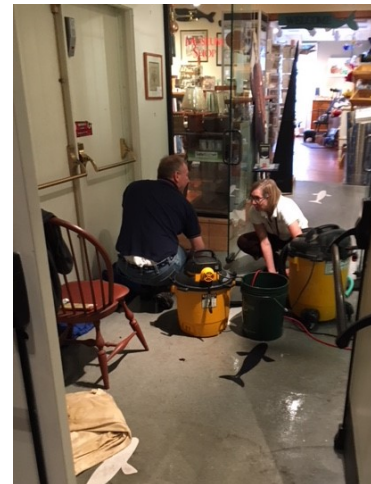
Fortunately, the outcome of this flood event was limited to a clean-up of the storm surge flood waters that entered the Connector connecting the Gift Shop to the Candle Factory. Rapid emergency mitigation measures by the NHA maintenance staff resulted in the erection of temporary flood barriers at the Connector exit doors, gift shop entrance and candle factory south elevation exit doors. Flood seepage during and subsequent to the event necessitated the removal of small amount of flood water which remained on the Connector and Candle Factory floors.

Photo flood clean-up: An “all-hands-on deck” event for the museum staff.

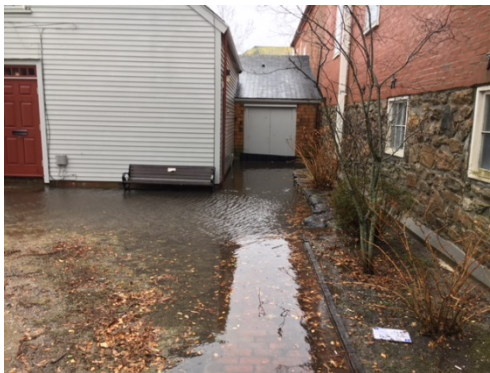
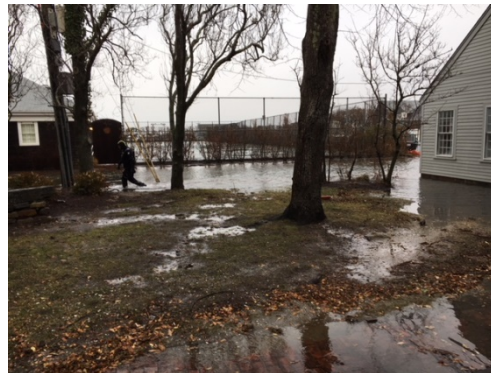
Gift Shop & Connector north Elevation. Photos taken during the flood illustrate the major pathway of the January 4th flood waters into the building were through the Connector exit doors seen in the photo on the left. The photo of the open area to the north of the Gift Shop illustrates the concurrent need to regrade this area to provide positive drainage to the east. Photo credit: Ed Rudd

- The exterior courtyard to the north of the Connector and Candle Factory also should be re-graded to a higher elevation. Regrading will provide positive drainage away from the museum complex footprint along the north elevation. Exiting area drainage lines also must be reconfigured, a stone retaining wall built along the S. Beach Street sidewalk and the area behind the retaining wall re-bricked or replanted with turf.

- Employ selective Dry Flood Proofing tactics at the Museum complex. Complete the design and if funding permits construct a new shed roof for the 145 sq. ft. expansion of the Gift Shop Connector at the north elevation. The draft design incorporates installation of a reinforced concrete footing wall that will in effect become a floodwall and provide a permanent barrier against the Category 3 flood level storm surge that penetrated the museum at this point. The new enclosed area by the Connector expansion should provide some additional storage space for the museum. Incorporate removable drop-in flood barriers into the design of the new exit doors at the relocated north Connector wall.

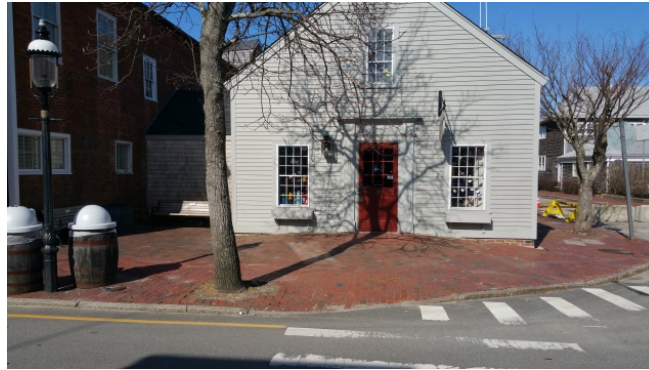
Gift Shop South Elevation. Installing temporary emergency flood barriers at the south elevation entrance to the gift shop may be effective in flooding slightly above the level of the door threshold, however, flood waters will most likely over time penetrate through the clapboard siding and enter the Gift Shop wing. The wood shingle siding of the Connector at the south elevation also will not provide a very effective barrier against any potential storm surge that rises above the brick foundation wall. The long term flood proofing solution for this building is elevation.

- The NYA should consider elevating the entire Gift Shop at a future date. This wing of the museum complex is in the most exposed location to both storm surge flooding and potential wind driven wave action. The gift Shop is a wood-frame on a brick/concrete foundation structure and elevation would be relatively straight forward. During our assessment my measurement of the floor elevation using the app *My Elevation* indicated a reading of 3 ft.

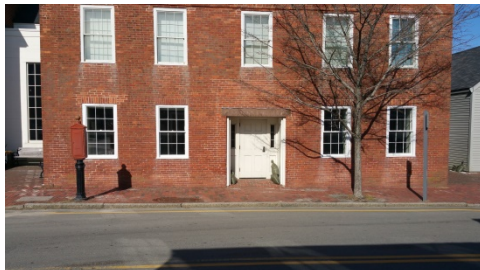
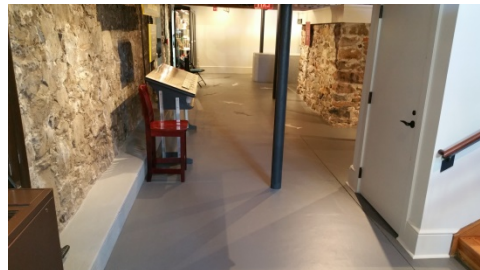
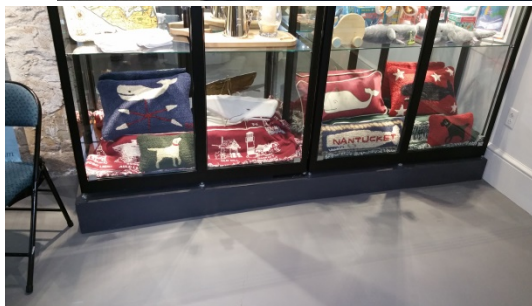
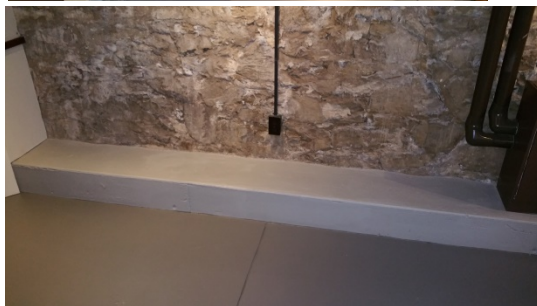
Candle Factory interior views. Top left, the entrance alcove of the Candle Factory could be easily adapted to accommodate two discrete slots for an emergency flood gate. Top right the concrete flooring and masonry walls make clean-up of any internal flood water that penetrates into the Candle Factory floor, the lowest elevation finished floor in the museum, a straight forward task. Bottom left and right, however, should a severe storm surge overwhelm the exterior flood barriers and enter into the Candle Factory low level display cases, electrical outlets and mechanical equipment might then be subject to immersion.

- Dry flood proofing is an appropriate treatment for the slab on grade Candle Factory with its solid masonry walls. There are no apparent portals of entry along the north elevation of the Candle factory. The South Elevation first floor doors are used for emergency exiting and would also be suitable to retrofitting an emergency drop-in flood barrier.

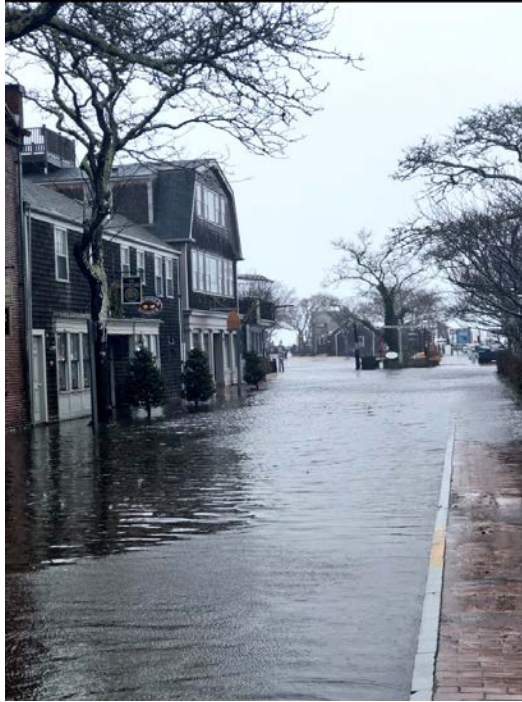
Photo of January 4th flooding on Main Street looking towards Straight Wharf to the east. The corner of the Thomas Macy warehouse is just visible on the left. Fortunately, the height of this storm surge did not penetrate to the first floor.

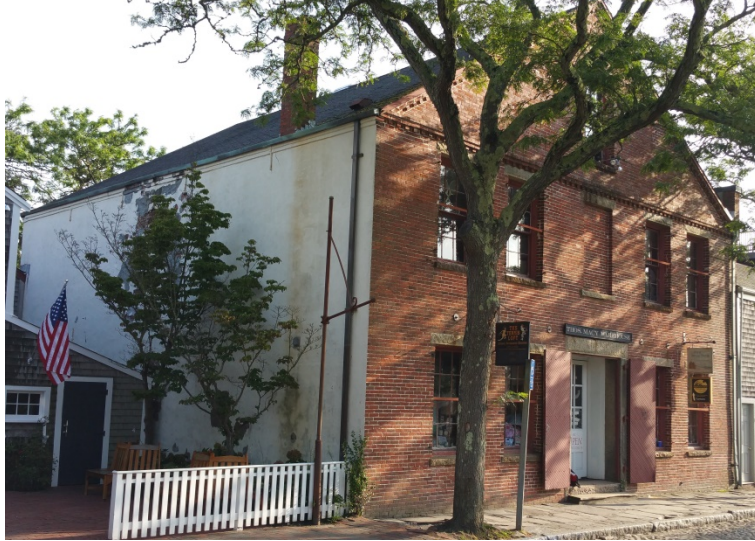
Front (south) Elevation of the Thomas Macy Warehouse.

Currently, the NHA is in the preliminary planning stage for a major preservation treatment of the exterior of the Warehouse that includes installing a new wind-resilient historically appropriate slate roof and gutters, exterior brick repointing and parge coating, and a comprehensive wood window preservation program.

- The recommended interior wet-flood proofing strategy for this building is to install all the new vulnerable building elements such as, accessible bathrooms, mechanical room, utilities such as fire suppression and HVAC equipment, and permanent exhibits only at the second floor level. Flood damage resistant materials should be used where necessary at the first floor level. Automatic shut-off valves must be installed on any sewer and fuel lines. FEMA has recently released an outstanding publication: FEMA P-348, Edition 2/February 2017 that provides profusely illustrated guidance in section 5.0 Mitigation Measures for Non-Residential Buildings, see: <https://www.fema.gov/media-library/assets/documents/3729>

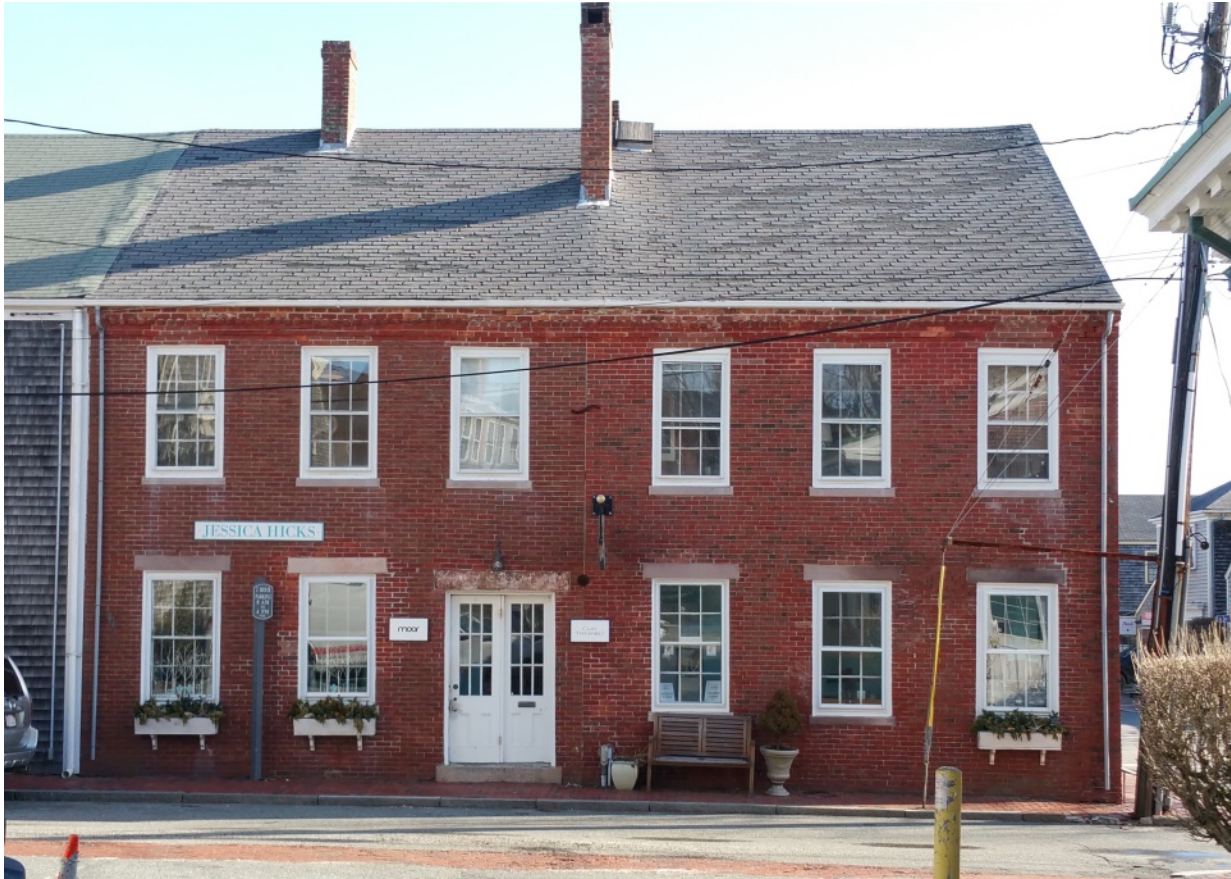
Photo of the West Elevation of #2 Union Street. Note the very poor condition of the asphalt roofing shingles. The roof hatch and chimney will also require repair. This work must be scheduled in the very near future.

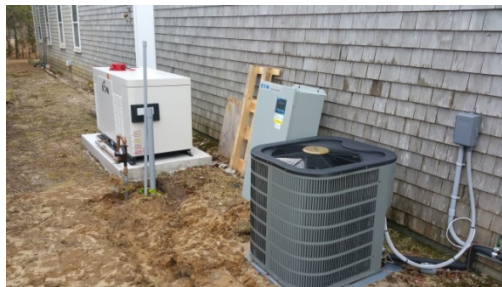
Gosnold Center Photo: A new 5KW emergency generator and a new condenser unit have recently been installed at the center

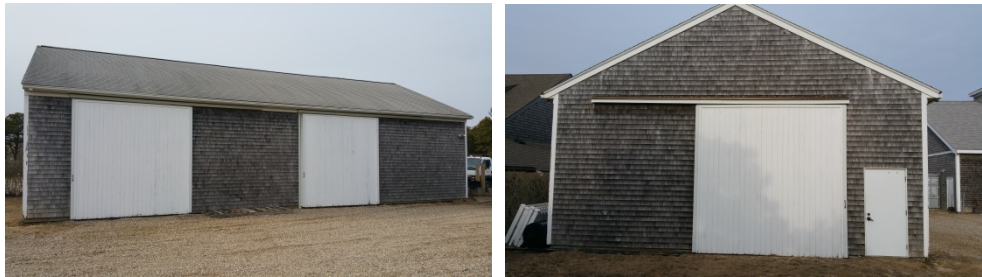
Photo Gosnold center Annex Building – left existing south Elevation, right existing west elevation. Rehabilitating this existing shell storage building into usable heated space will be a major project.

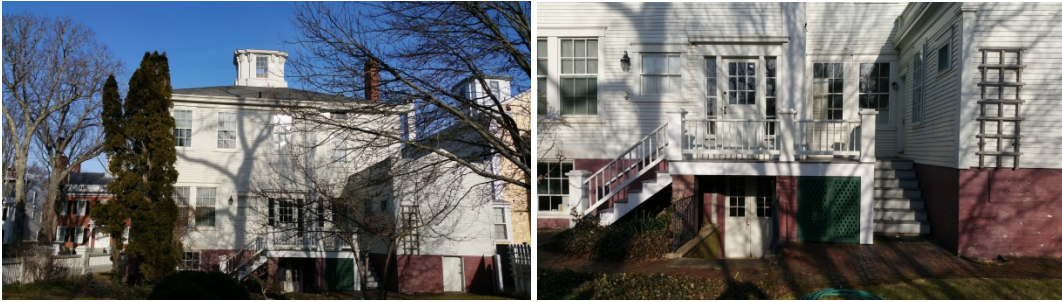
Photo Rear Elevation of the Hadwen House – Developing an appropriate architectural plan for the addition of an elevator and ADA accessible ramp to the rear deck (first floor) level of the Hadwen house for this character defining exterior elevation will be a challenge. The accessibility enhancement must be designed so that the exterior appearance of this NHL home is not diminished.

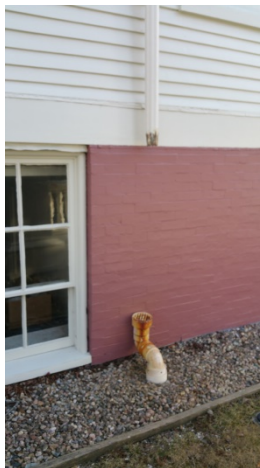
Photo East Elevation of the Hadwen House – all the downspouts along the perimeter of the Hadwen house must be immediately checked and re-connected to the subsurface storm water drains.

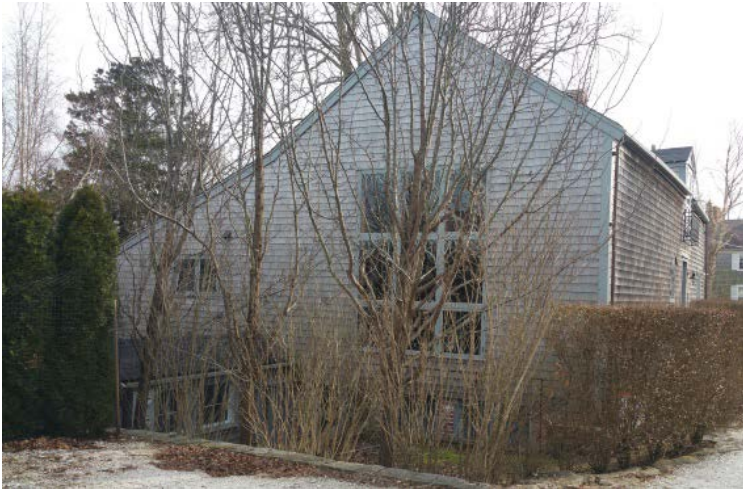
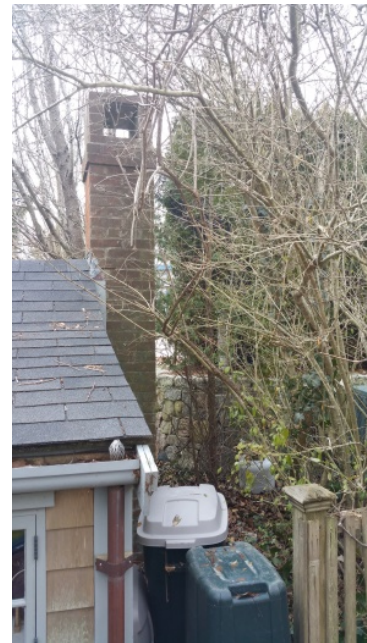
Photo Rear Elevation of Greater Light – It is advisable to instigate a major pruning project in this area in 2018.

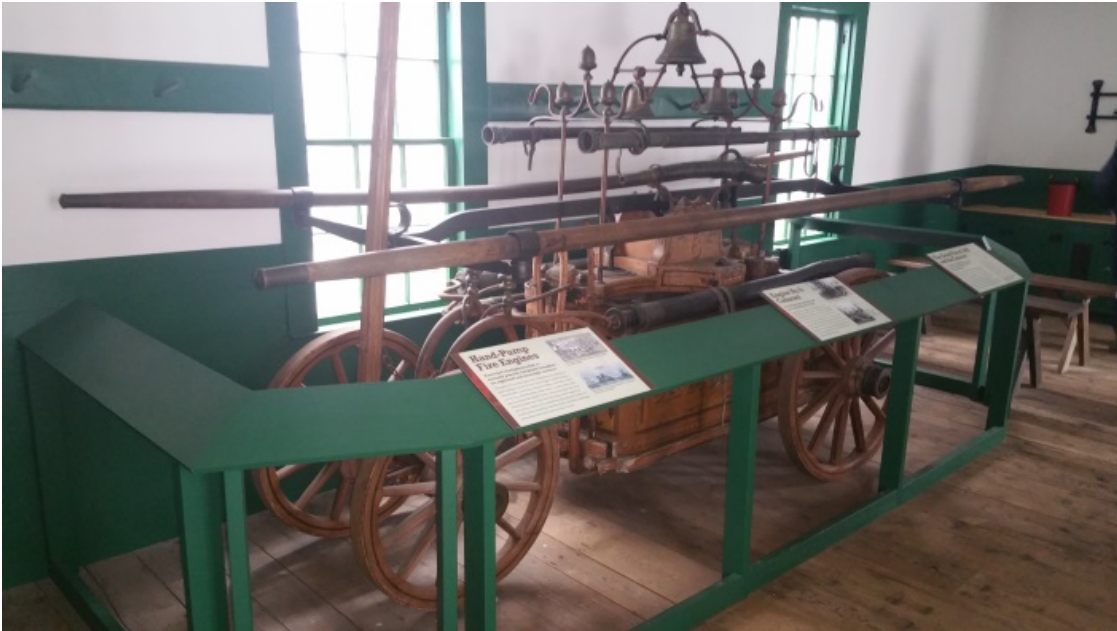
Photo of the interior of the Fire Cart Hose House – this picture shows the existing railing and exhibit panels now on the interior of the Cart House. Relocating these railings and adding Plexiglas barriers should allow visitors to view the interior fire-fighting equipment, interactive displays, and video presentation without a docent providing security.

- Move existing interpretive panels and install new railings with Plexiglas barriers to allow visitors to access the Cart house without a docent present. [FY18CH36]

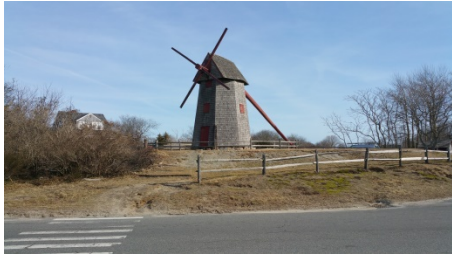
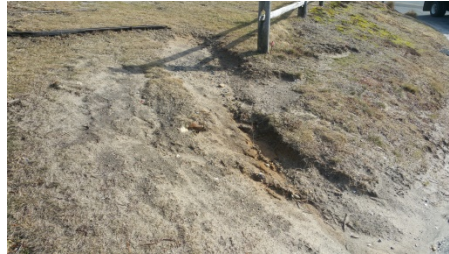
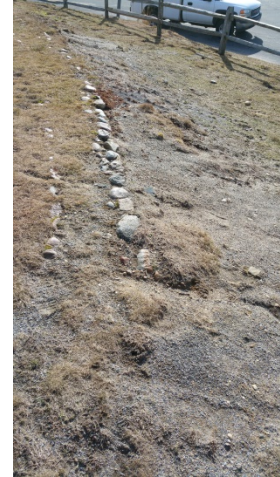
Three Old Mill photos from the south: The photo on the left shows the existing access from Prospect Street, the center photo gives a clear indication of severe erosion that now is a safety hazard, and photo on the right shows the area where it will be necessary to construct a stone retaining wall.

- Design/Build a Prospect Street pedestrian access stairway up to the wheel track elevation. The recommended design would utilize large granite treads that are woven into a random coursed, dry-laid field-stone retaining wall to the east where there has been extensive erosion of the existing turf slope. [FY18OM8]
- Design/Build an ADA compliant entry and access path from the main Old Mill site entrance to the mill entrance threshold. [FY20OM37]
- Remove existing cobblestones, regrade a level crushed stone base and relay cobble stones along the entire circumference of the wheel track. [FT22OM38]
- Re-shingle the mill structure. [FT22OM38]

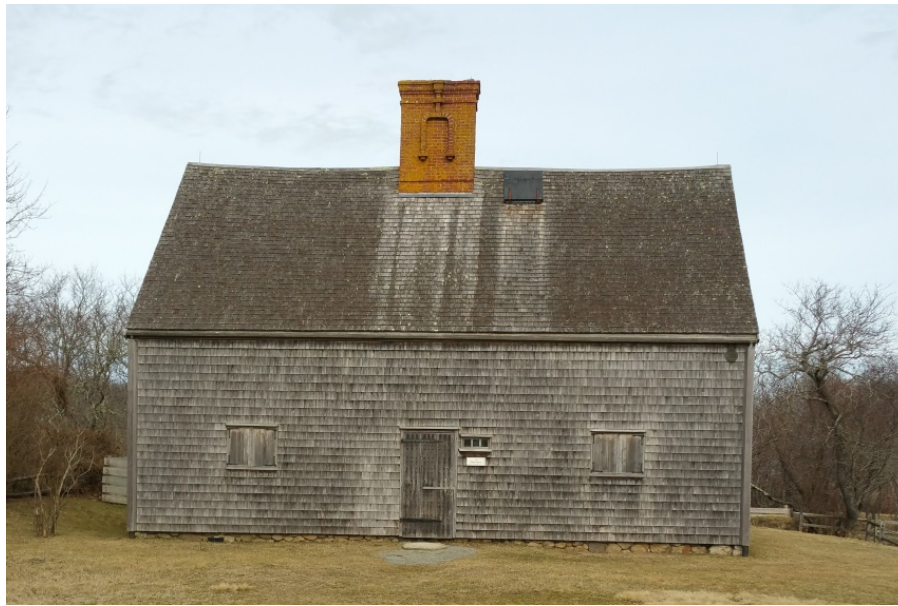
Photo of the Front Elevation of the Oldest House. The roof and siding shingles are now more than three-quarters of their way through the expected service life of these materials.

- Install new roof shingles, clean chimney brick, repoint as necessary, inspect repair/replace roof gutter system. [FY21OH40]
- Re-shingle all four elevations of the Oldest House. Inspect repair/replace window trim. . [FY21OH41]

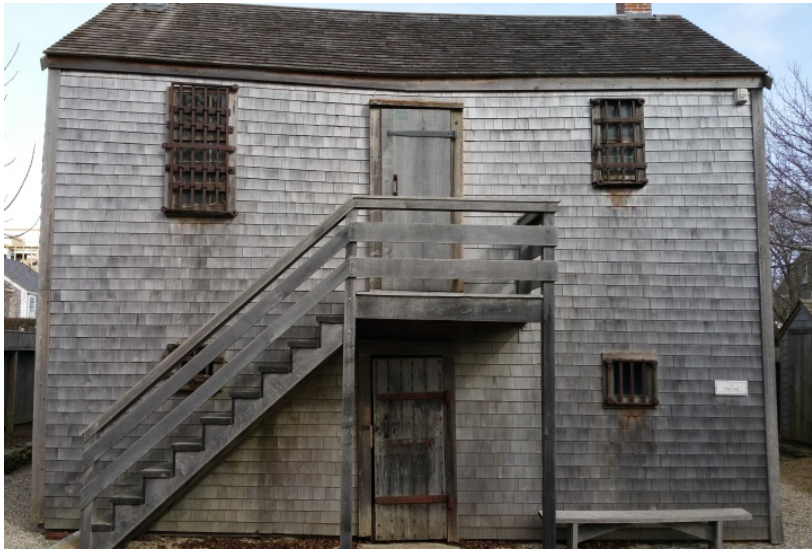
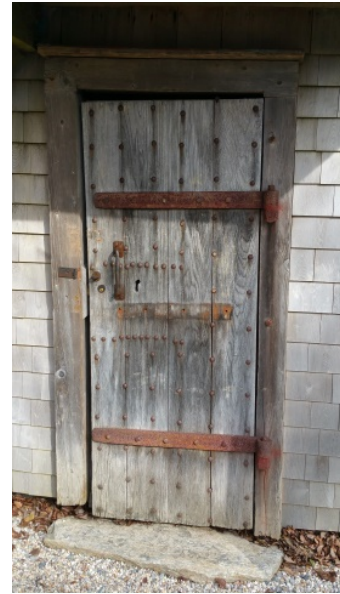
Photo of the Front Elevation of the Old Goal – The front door of the Old Goal is a significant character defining feature of this historic structure and previous restoration efforts have respected the historic integrity of this feature by avoiding “heavy-handed” and unnecessary replacement of worn or rusted elements.

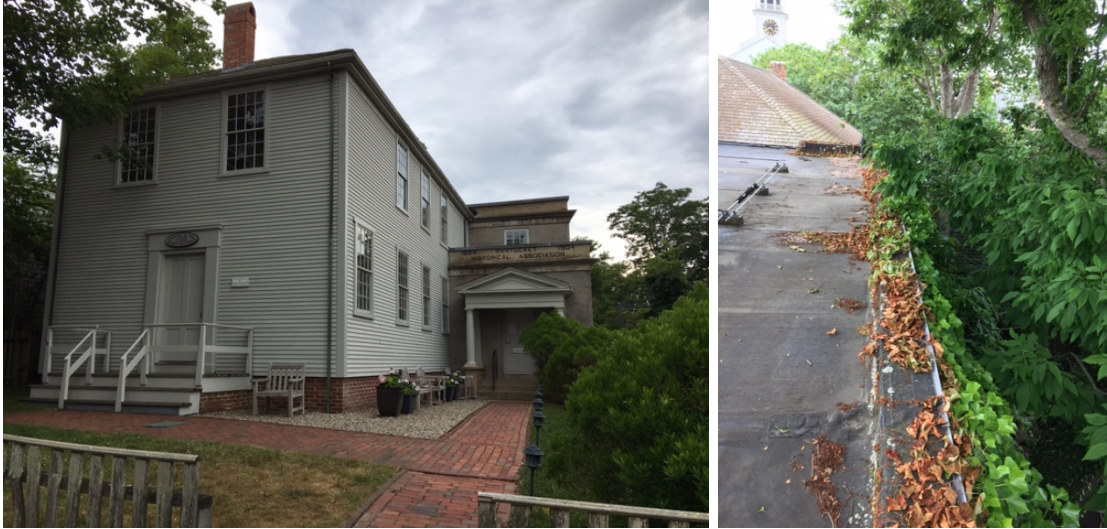
Photo of the Front Elevation of the Quaker Meeting House – Overhanging tree branches can damage a roof or gutters in a wind storm and leaf debris will clog gutters and downspouts.

A critical 2018 Preservation Maintenance Task, illustrated below, at both the Quaker Meeting House and the Research Library is to trim all the over-hanging tree limbs above the roofs of both structures.

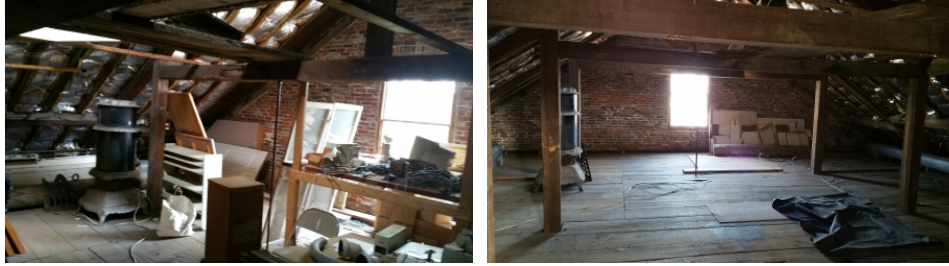
Photos of the Thomas Macy Warehouse Attic before, and after, the thorough 2017 “housekeeping” effort. The first step in rehabilitating the Macy Warehouse was cleaning out the attic space. The photo on the left shows the attic space in August 2017; the photo on the right shows the same space in February 2018.

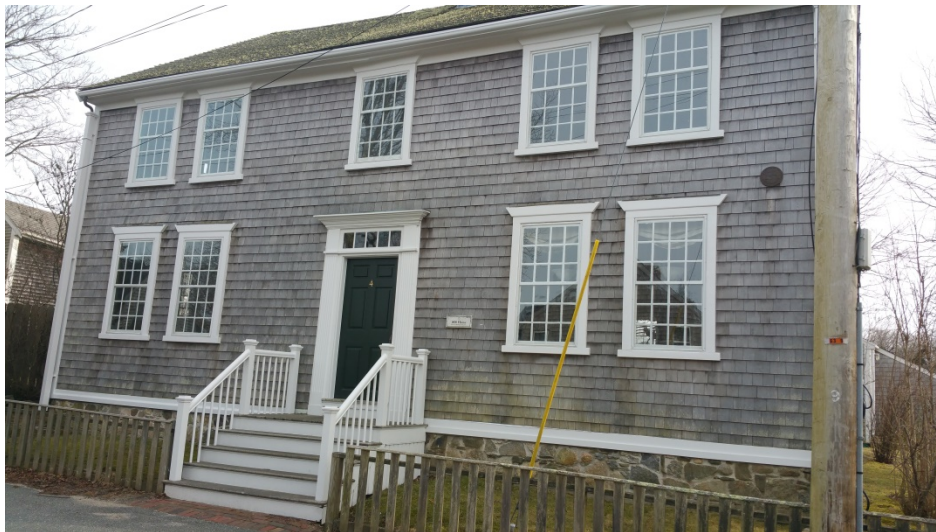
Photo of the Front Elevation of the 1800 House. The exterior storm windows do not detract from the historic appearance of this structure and significantly reduce the effects of weathering on the wood double hung sash windows. The wood shingle roof and exterior shingle siding appear to be more than halfway through their respective service life.

- Install new roof shingles, clean chimney brick, repoint as necessary, Inspect repair/replace roof gutter system. [FY21EH44]
- Re-shingle all four elevations of the 1800 House. Inspect repair/replace window trim. [FY21EH45]

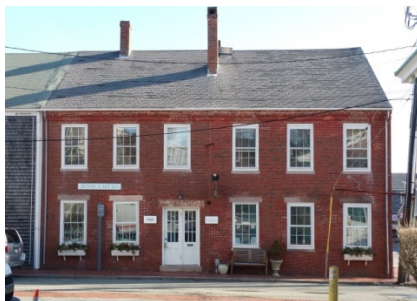
Photo of the Front Elevation of #2 Union Street on the left. The asphalt roof needs to be replaced. Seen in the detail photo on the right, the sidewalk on the west, or leeward side, from the prevailing wind from the January 4th storm was littered with asphalt pieces off the #2 Union Street roof.

- Install new roof shingles, clean chimney brick, repoint as necessary, Inspect repair/replace roof gutter system. [FY19TU46]
- Repair cracks in brick masonry gable wall; repoint all the exterior brick walls as required. [FY19TU47]
- Complete a comprehensive window preservation treatment project for all the historic wood windows on all three elevations of this building. [FY20TU48]
- Commission and Condition Assessment of #2 Union Street with accompanying research to prepare a historic data section.
- Forge a partnership with a university preservation program with the objective of preparing a set of record drawings of this historic structure.
