Evaluating and Improving the Resilience of Wastewater Treatment Facilities and Above Ground Storage Tanks in Upper Narragansett Bay to Coastal Flooding

Ocean Engineering Senior Design OCE 496

10 May 2019

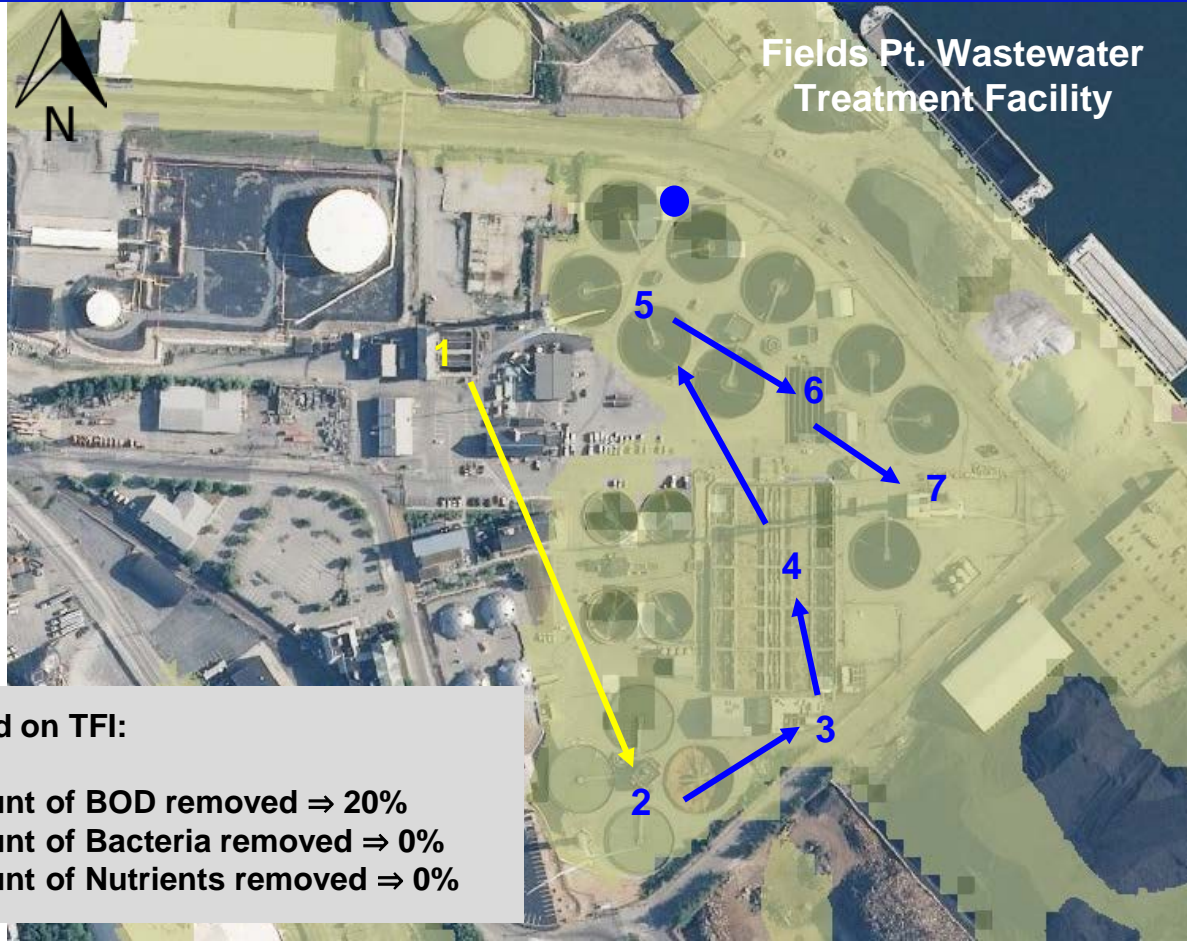
Stormtools Design Elevation - 100 Year Storm + 0 ft SLR

Based on TFI:

Amount of BOD removed ⇒ 20%
Amount of Bacteria removed ⇒ 0%
Amount of Nutrients removed ⇒ 0%

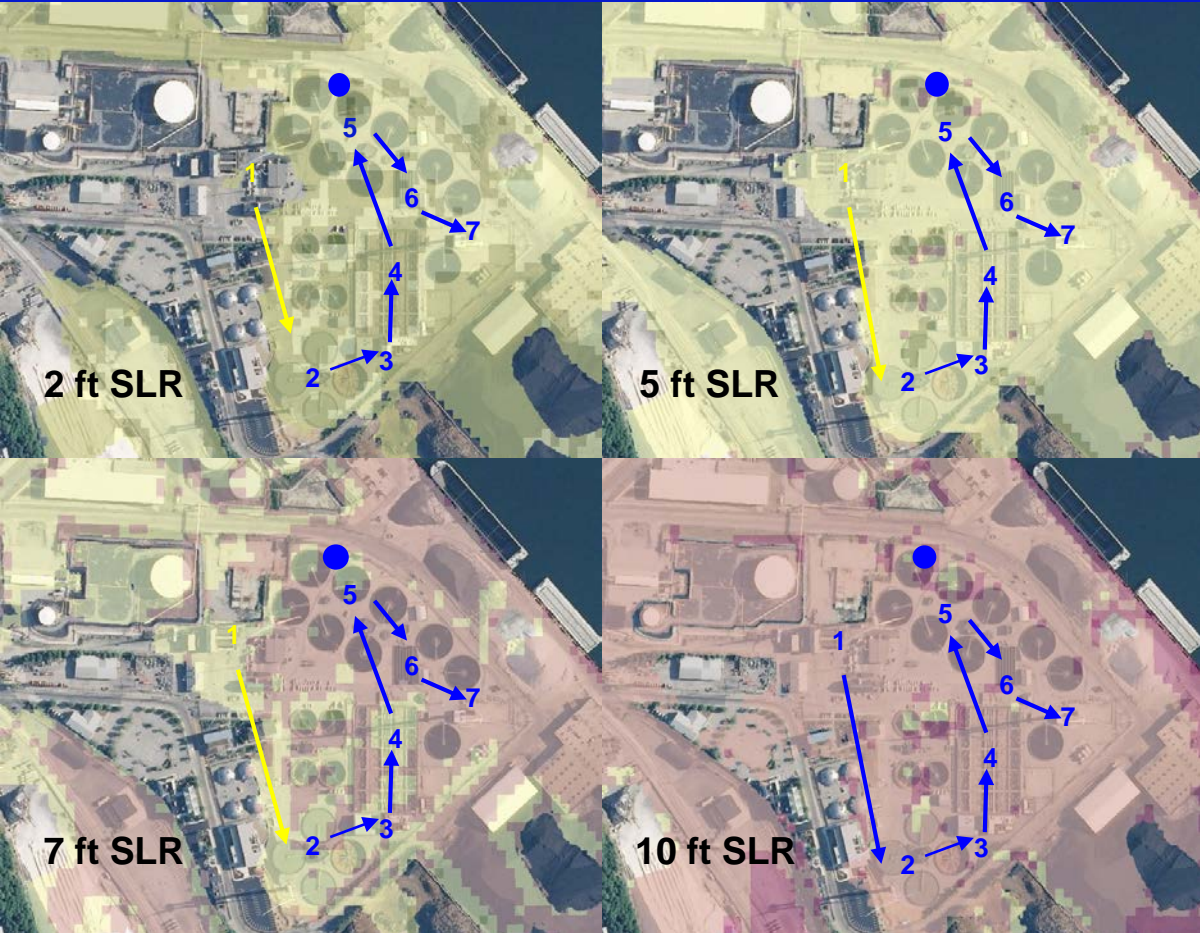
Stormtools Design Elevation - 100 Year Storm + SLR

- *Inundation (ft NAVD88)*
 - 12.0 (FEMA, no SLR)
 - 17.7 (SDE, 0 ft SLR)
 - 19.9 (SDE, 2 ft SLR)
 - 23.2 (SDE, 5 ft SLR)
 - 25.4 (SDE, 7 ft SLR)
 - 28.9 (SDE, 10 ft SLR)

- Based on TFI : 2ft, 5ft, 7ft SLR
 - Amount of BOD removed ⇒ 20%
 - Amount of Bacteria removed ⇒ 0%
 - Amount of Nutrients removed ⇒ 0%
- Based on TFI, no constituents removed in 10ft SLR case

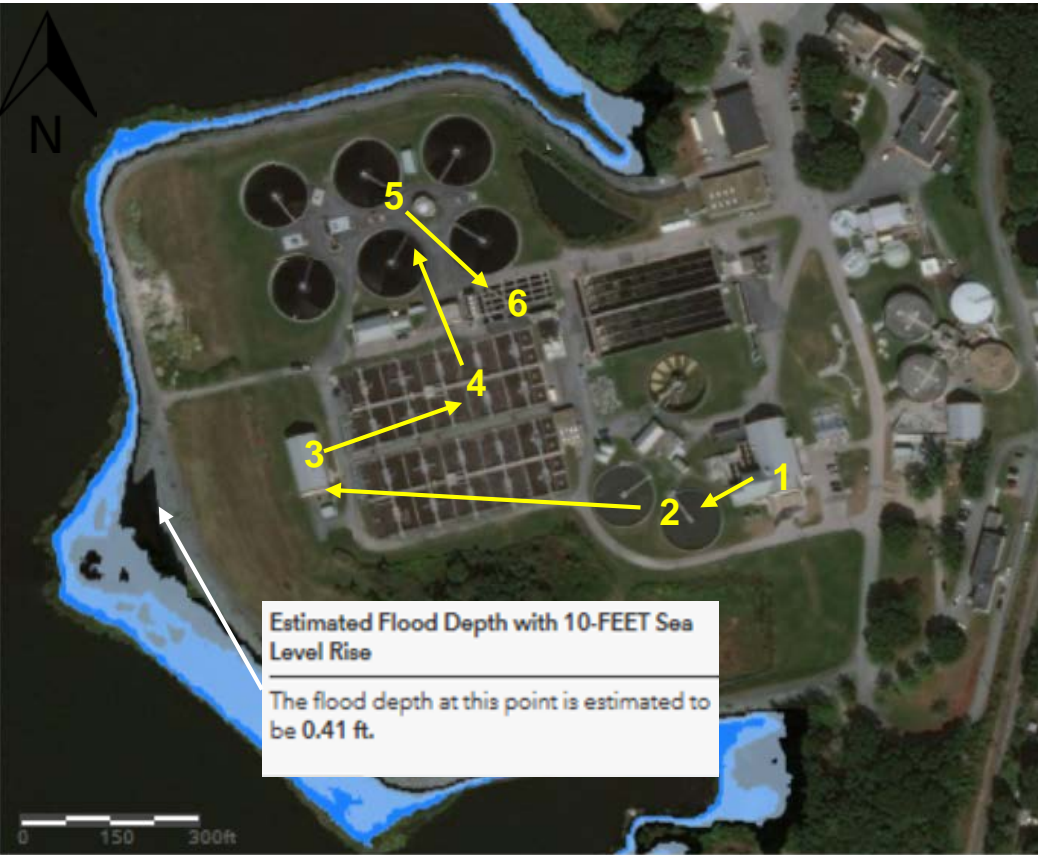
Estimated Flood Depth with 10-FEET Sea Level Rise

- Berm withstands SLR
- No impact to any components of wastewater treatment facility
- All components still operational with 10 feet of sea level rise

The flood depth at this point is estimated to be 0.41 ft.

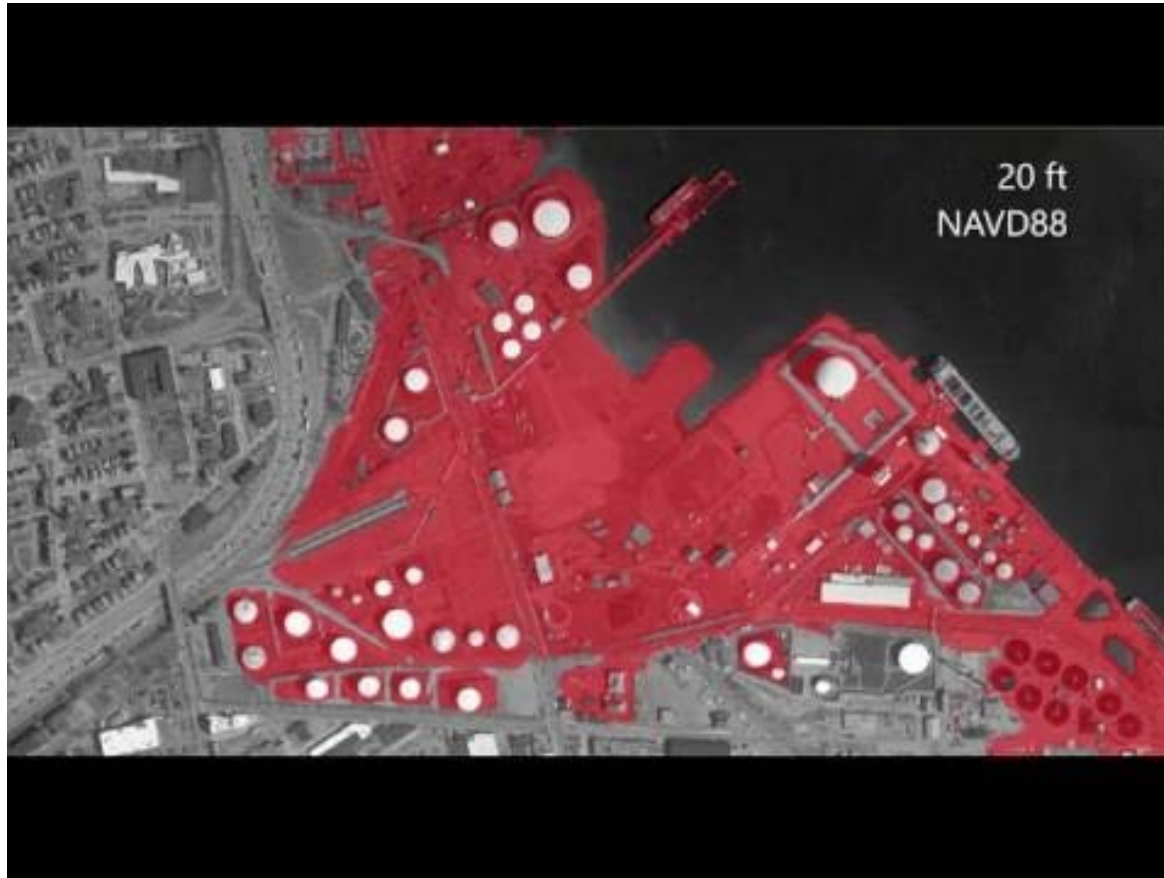
Inundation Path based on Digital Surface Model (DSM)

- All sites without containment berms are immediately inundated
- 60% AST's inundated 100 yr storm without SLR
- 98% AST's inundated 100 yr storm with 10 ft SLR

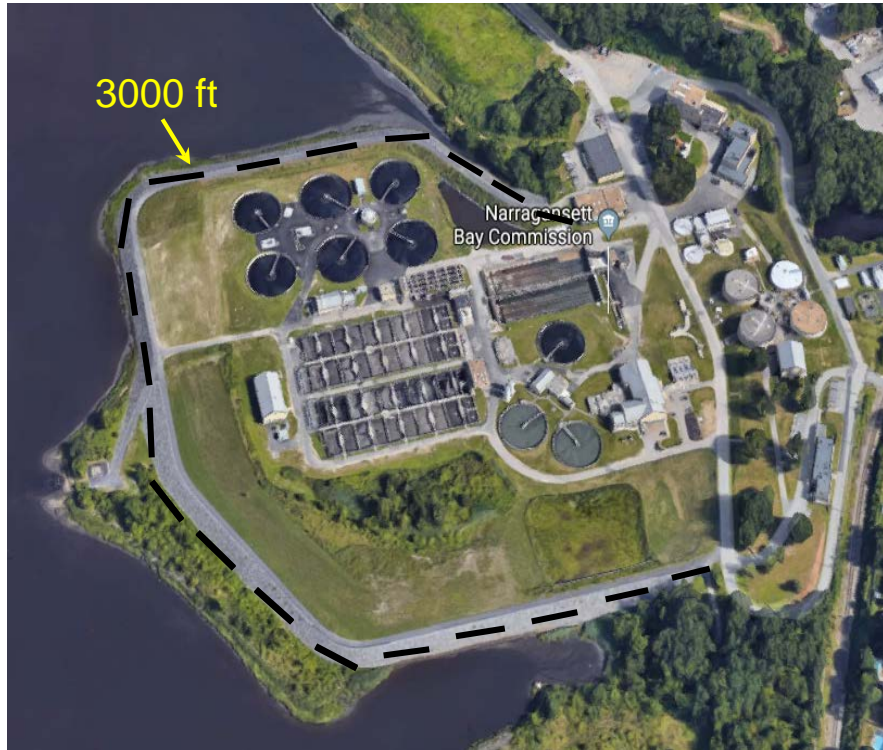
Bucklin Pt. Berm Upgrade Proposal

Current Berm Height approximately 20.5 ft (NAVD88)

Total Berm Length approximately 3000 ft.

Storm Scenario	Base Flood Elevation (ft NAVD88)	Berm Upgrade (ft)
Current Berm Height	20.5	-
100 Year + 0ft SLR	22	2.5
100 Year + 2ft SLR	24.1	4.6
100 Year + 3ft SLR	25.1	5.6
100 Year + 5ft SLR	27.2	7.7
100 Year + 7ft SLR	29.4	9.9
100 Year + 10ft SLR	32.6	13.1

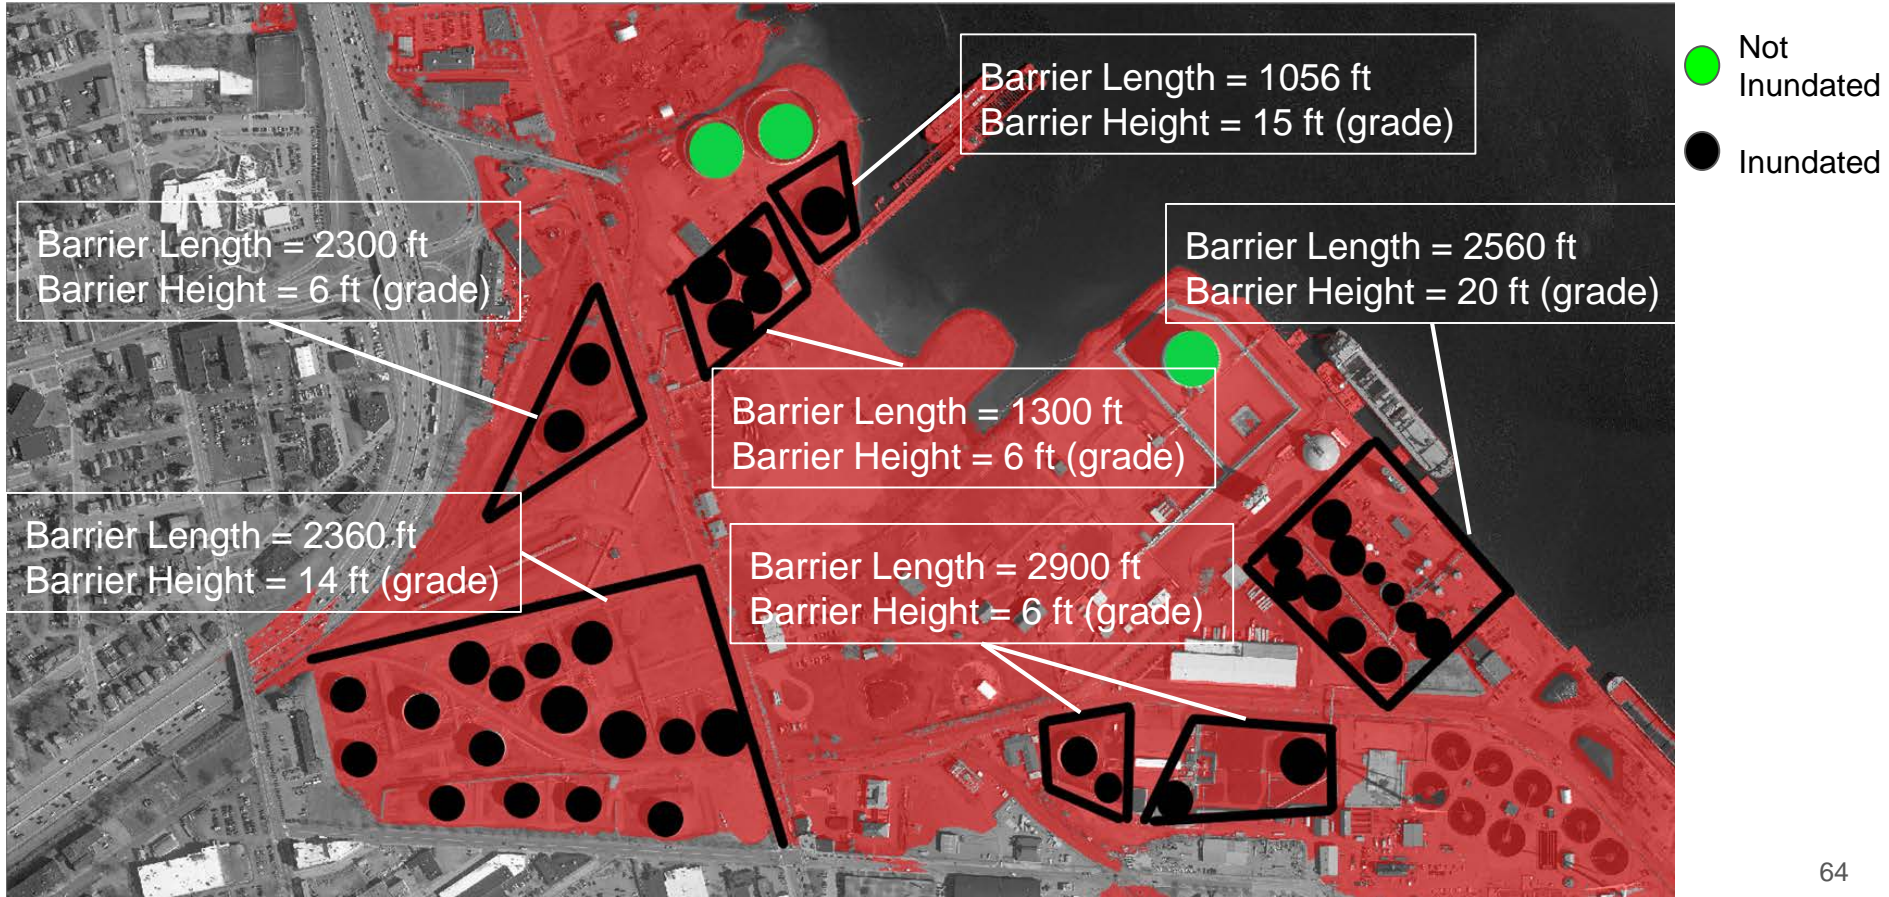
Proposed Barriers for ASTs - 100 Year Storm + 10 ft SLR

- 60% of ASTs inundated for 100 yr storm without SLR
- 74% of ASTs inundated for 100 year with 5ft SLR
- 98% ASTs inundated for 100 yr storm with 10 ft SLR
- It is recommended that all tanks are anchored and barriers are added or height is increased
