High-Tides and Flooding on Easy Street

A progress report and key findings

Charles D. Larson, P.E. Manager of Strategic Projects Town of Nantucket

July 10, 2020

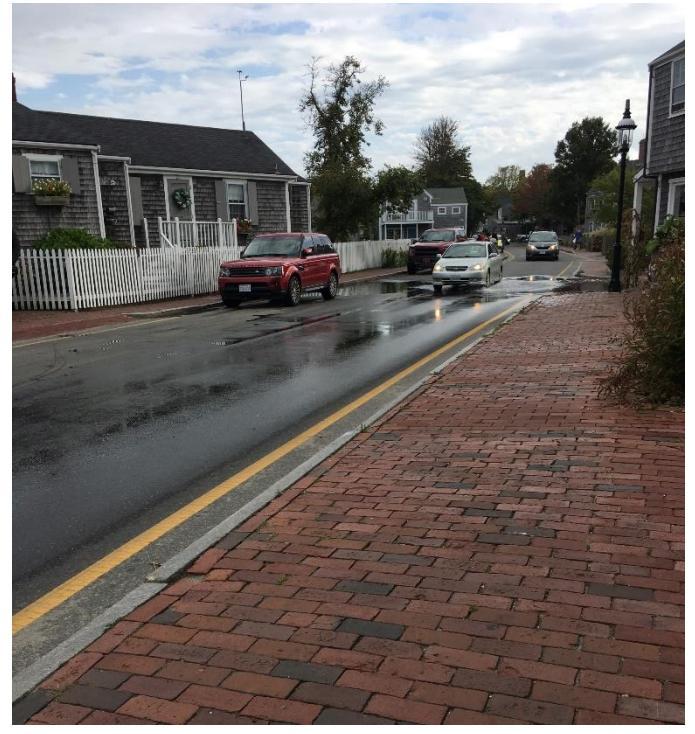
- Oct. 2, 2019, 3:55 PM, the confirmed water elevation was 1.1 feet MHHW. Photographs of the locations are shown in Figures 1 and 2, below. Rainfall in the previous 72 hours was recorded to be a total of 0.09 inches and is considered insignificant to the flooding observed on the roadway.
- Nov. 28, 2018, 4:04 PM, the confirmed water level was 1.65 MHHW. Photographs of this event are shown in Figures 3 and 4, below. Rainfall in the previous 48 hours was a totals 0.6 inches and seems unlikely as a contributor to storm water flooding on the roadway.

Figure 1, High-tide flooding on Easy Street at Oak Street on 10/2/2019 (15:55 local time)¹

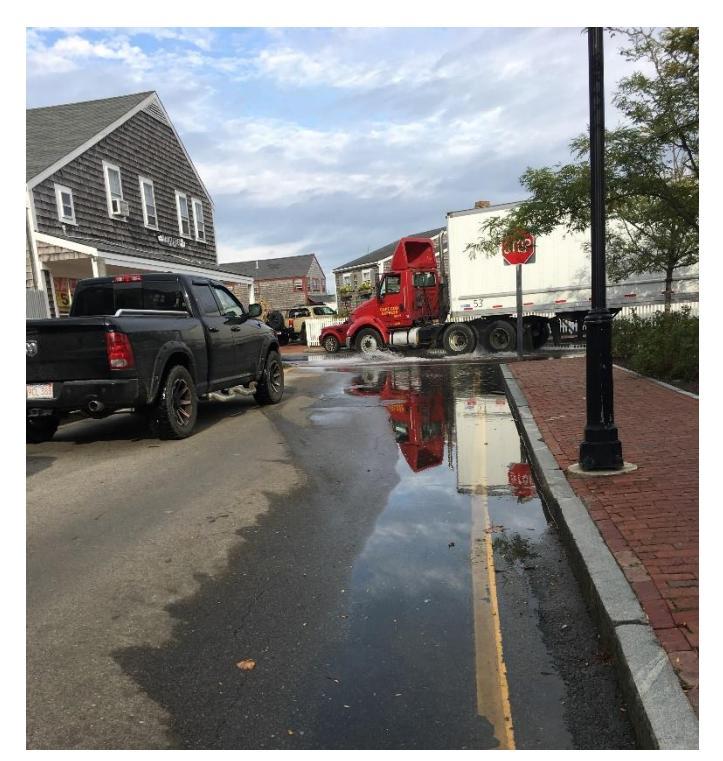
Figure 2, High-tide flooding on Easy Street at Broad Street on 10/2/2019 (15:56 local time)

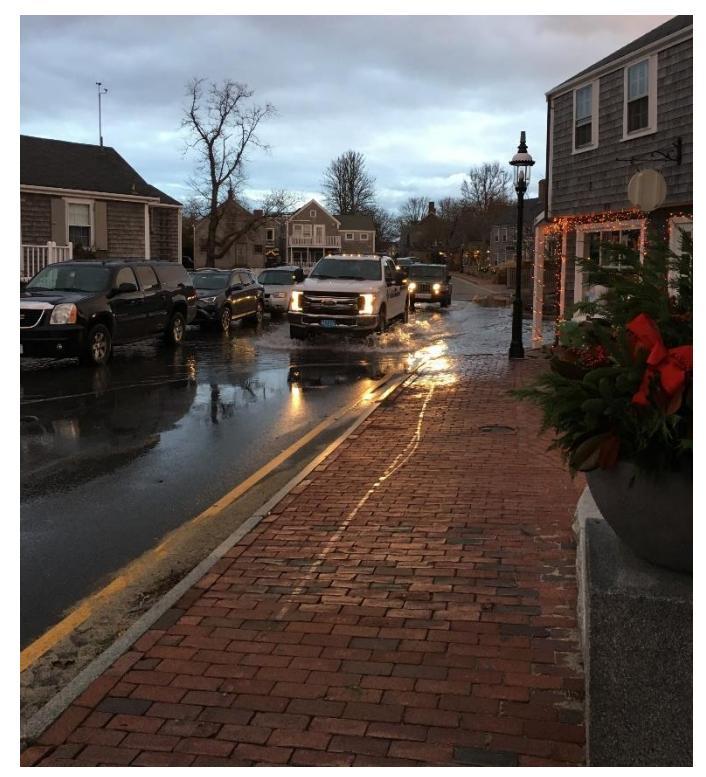
Figure 3, High-tide flooding on Easy Street at Oak Street on 11/28/2018 (16:03 local time)²

Water levels in the November 28, 2018 flooding event are approximately 6 inches deeper than the October 2, 2019 event. This difference can be seen in the photographs.

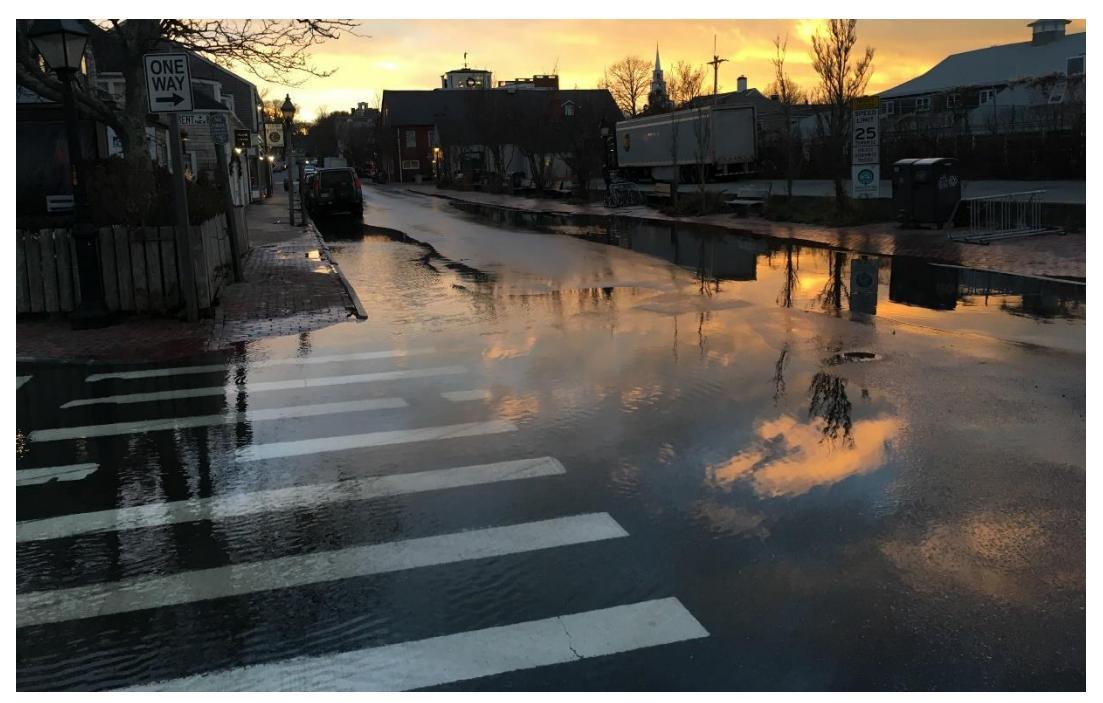
Figure 4, High-tide flooding on Broad Street at Easy Street on 11/28/2018 (16:04 local time)

- Flooding on lower Broad Street at Easy Street is found to be caused be a storm water outfall that has no apparent backflow device. This needs further investigation.

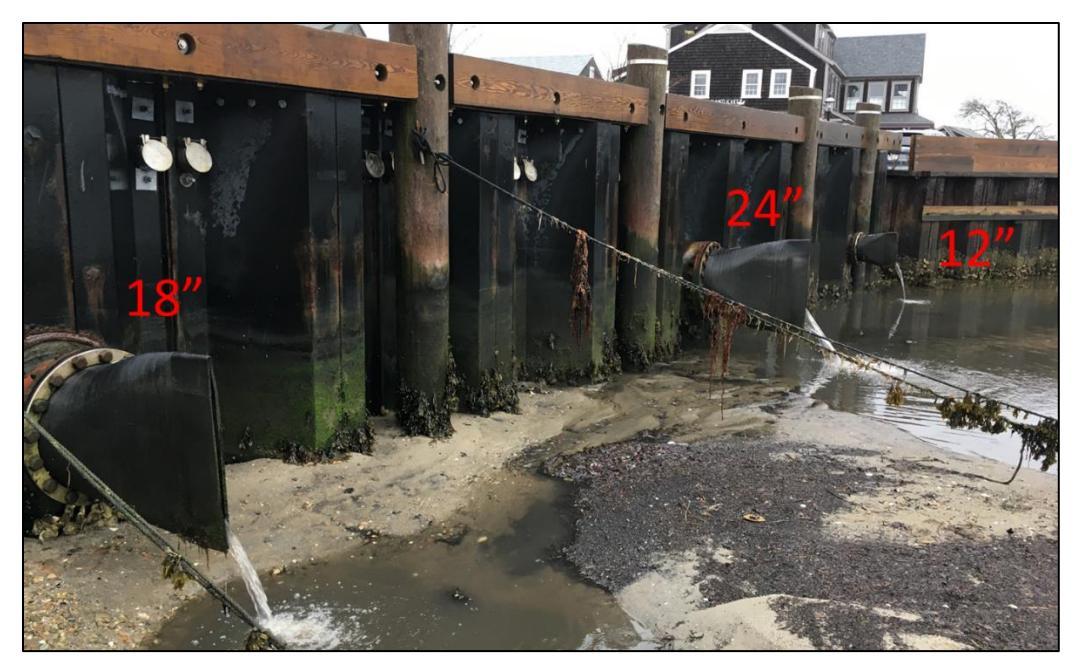
The roadway catch-basins and the storm water drainage system for Easy Street at Oak Street drains directly to Nantucket Harbor at the bulkhead. Backflow prevention valves were installed on the outfalls during the 2016 bulkhead construction project. The backflow valves were inspected in February 2020 and found to be deformed and deteriorated such that water at high-tide is able to backflow into the storm water system. Three outfalls were identified at the bulkhead and are shown in Figure 13.

Figure 13, Storm Water Outfalls and Check Valves at the Easy Street Bulkhead (2/13/2020)⁸

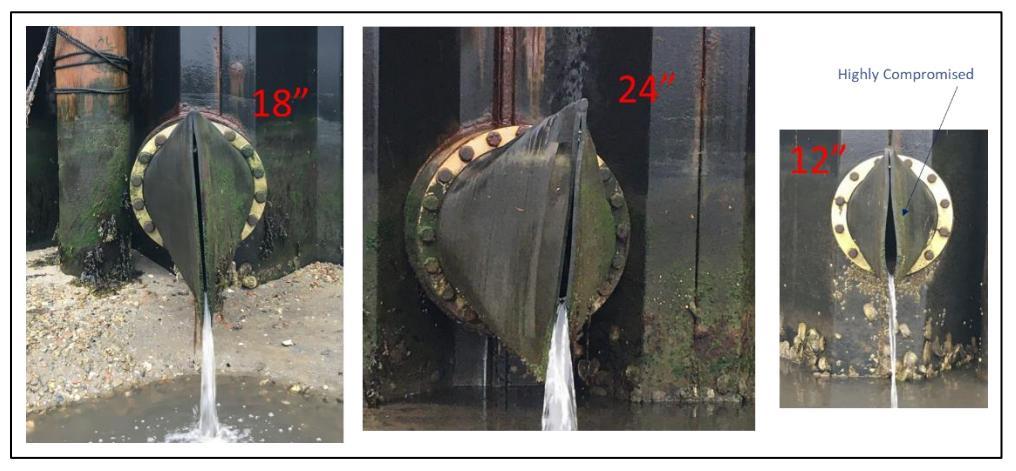
A closer examination of each valve is shown in Figure 14. The 12- inch diameter valve appears to have the largest amount of deformation and does not allow the valve to close to prevent backflow. Based on the available plans for the storm water system, the 12-inch diameter outlet is connected to the drains at the intersection of Easy Street and Oak Street. These are the locations with the flooding shown in Figures 1 and 3.

Figure 14, Visual Inspection of the ProFlex Check Valves at the Easy Street Bulkhead (2/13/2020)

- The immediate problem causing roadway flooding on Easy Street at Oak Street is attributable to the deformed and defective backflow devices for the outfalls at the bulkhead.

The valve manufacturer (ProFlex) and the regional distributor were contacted to discuss the problem. A representative of the manufacturer is willing to come on-site to evaluate the valves and determine if the manufacturer will provide replacements under warranty coverage.

- The situation can be improved by replacement of the backflow devices.
- As sea-levels continue to rise, there will be a point in time in which backflow devices may not remain effective at stopping backflow. It is also likely that water levels that exceed the elevation of the street may find other paths to the roadway surface.
