High-Tides and Flooding on Easy Street

A progress report and key findings

Charles D. Larson, P.E. Manager of Strategic Projects Town of Nantucket

July 10, 2020

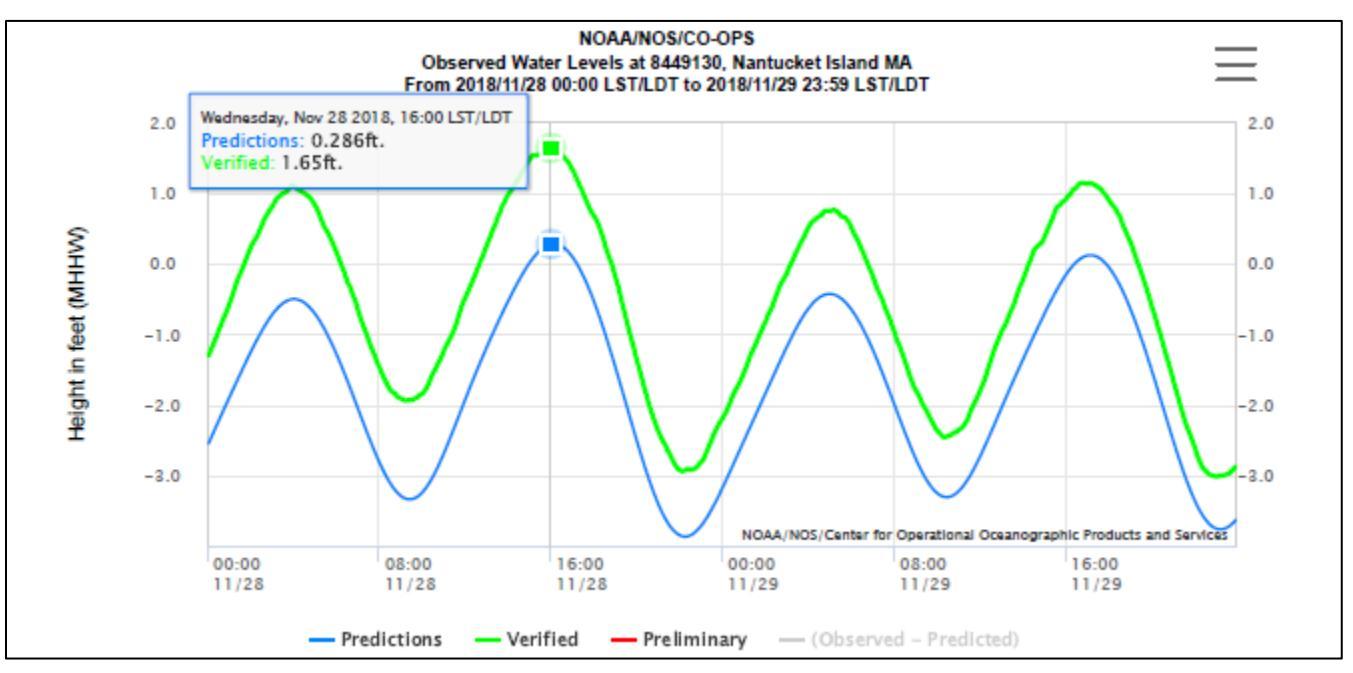
Figure 5, Water Levels Recorded for 10/2/2019 and 10/3/2019³

Water levels in the November 28, 2018 flooding event are approximately 6 inches deeper than the October 2, 2019 event. This difference can be seen in the photographs.

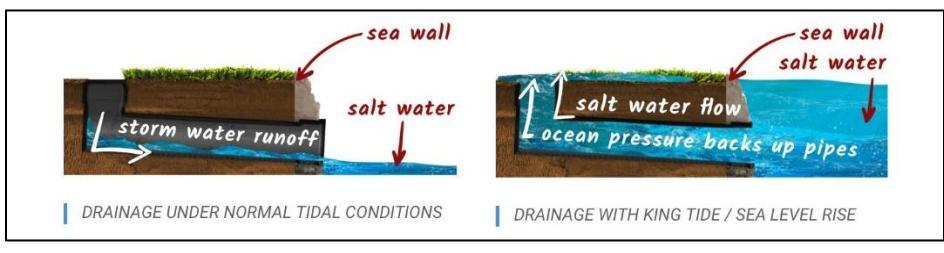
Figure 7, How High-tide Flooding Occurs

A simple illustration of high-tide flooding on Easy Street is shown in Figure 7⁵.

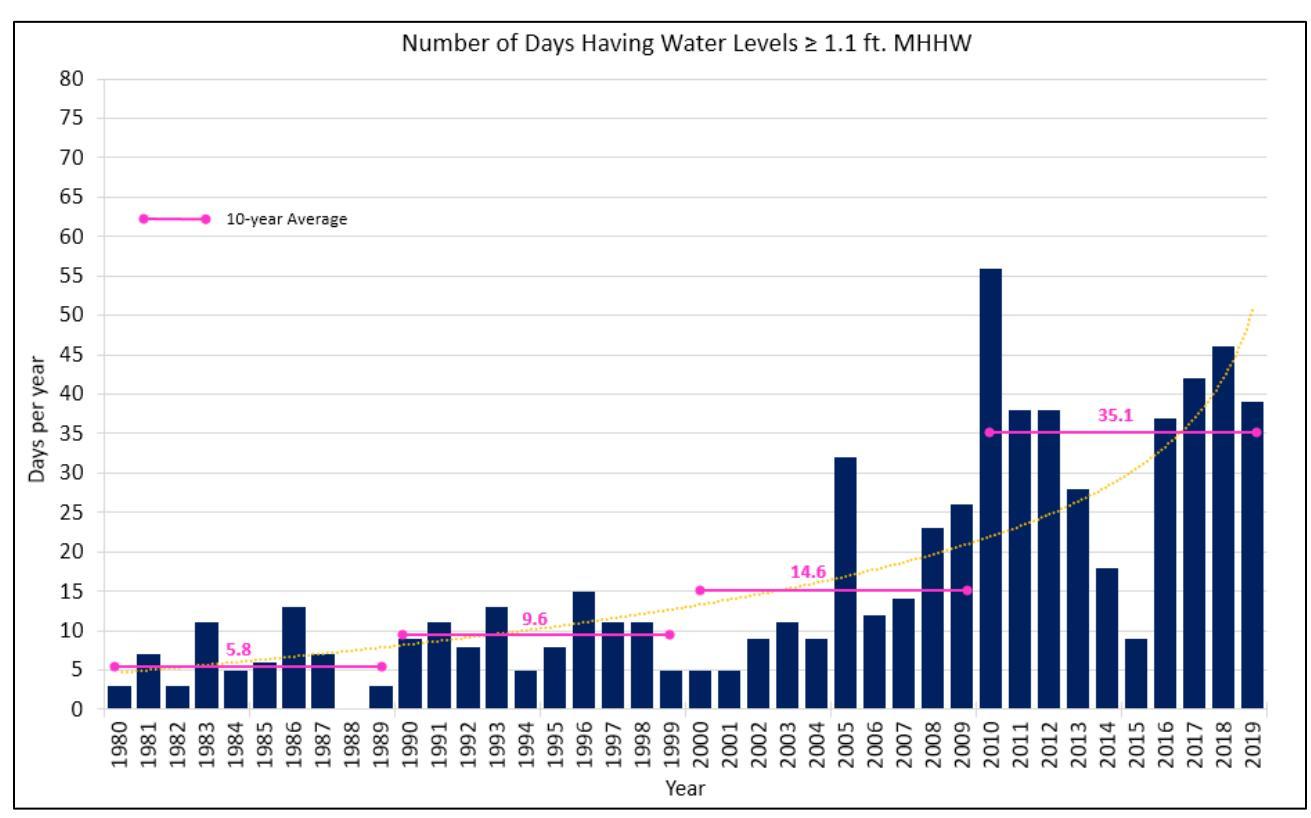
Figure 8, The Number of Days per Year with Water Levels at or Exceeding 1.1 feet MHHW

NOAA water level data for the Nantucket Harbor Tide Gauge were downloaded for the time period of January 1, 1980 through December 31, 2019, representing the last 40 years of available information. This data was summarized to produce Figure 8, showing the number of days per year that water levels were 1.1 feet MHHW or higher from 1980 through 2019. The 10-year average is also shown in Figure 8.

- More frequent high-tide flooding has been observed and documented on Easy Street.
- 1.1 feet MHHW occurred, on average, every 10 days in 2010-2019, an increase from an average of every 63 days in 1980-1989.

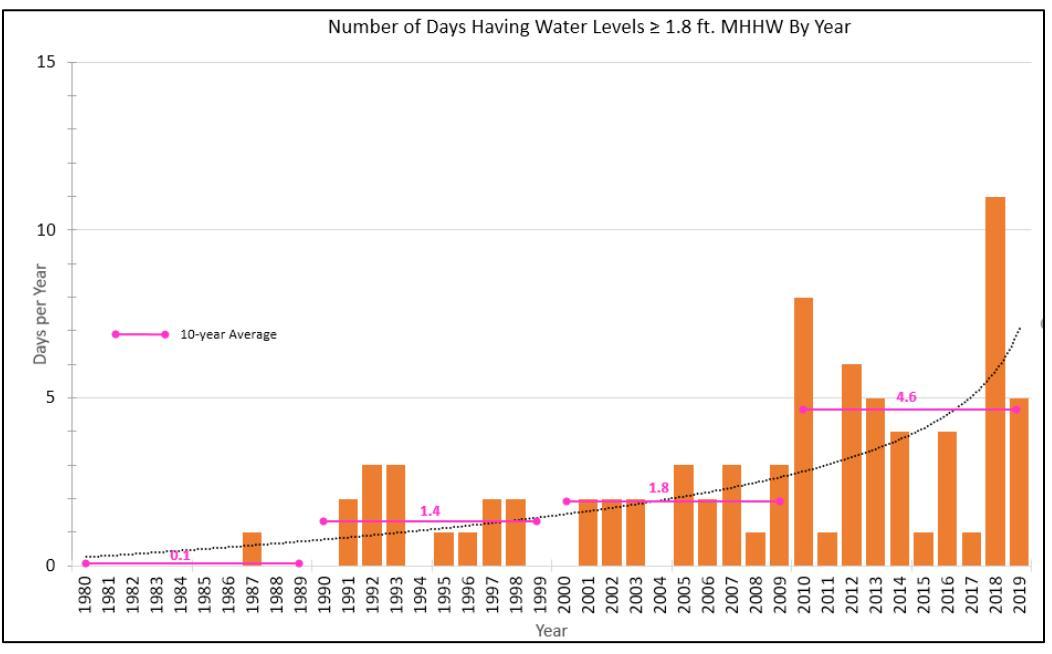
Figure 10, The Number of Days per Year with Water Levels at or Exceeding 1.1 feet MHHW

Figure 10 shows the number of days per year that water levels were 1.8 feet MHHW or higher from 1980 through 2019. The 10-year average is also shown.

Similar to the trends seen earlier, the number of days with higher water levels is increasing. 1.8 feet MHHW occurred on an average of 4.6 times a year for 2010-2019, a significant growth from an average of 1.8 times a year for 2000-2009, 1.4 times a year in 1990-1999, and just once in the decade preceding.

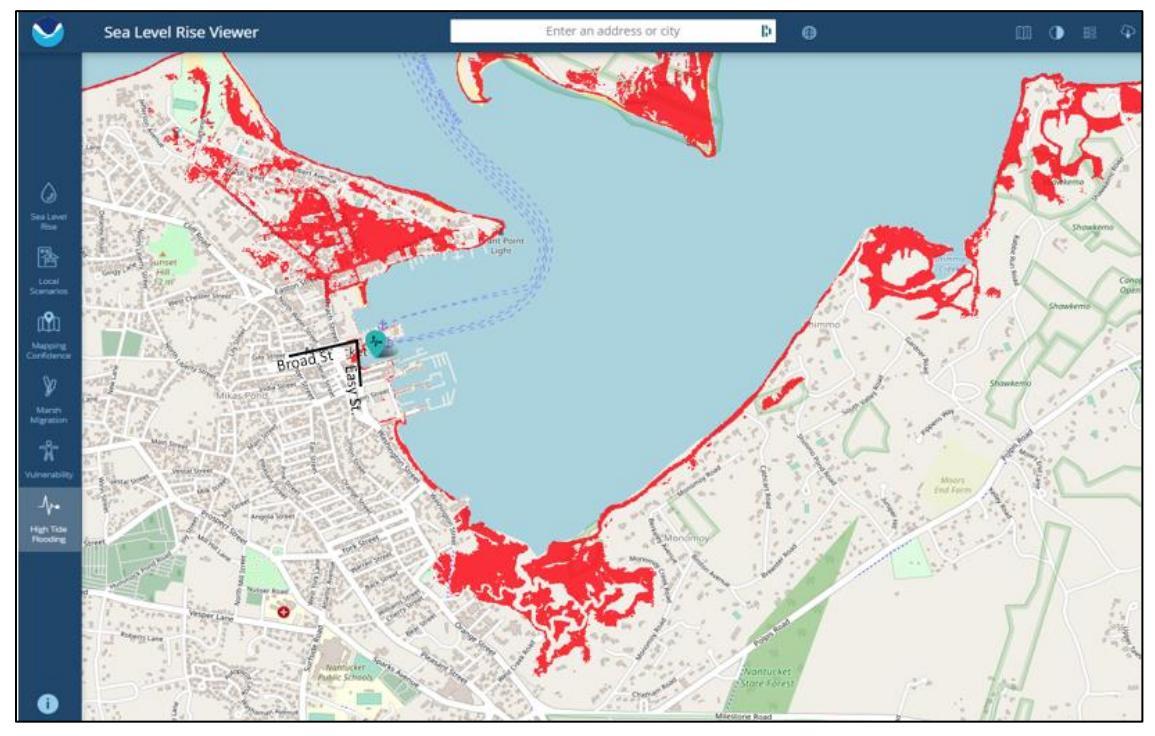
Figure 11, Areas with Flooding at 1.8 feet MHHW.

The impacts extend to areas beyond Easy St. and include properties, roadways and infrastructure at lower elevations. Figure 11 shows the areas impacted at 1.8 feet MHHW based on inundation modeling by NOAA⁷.

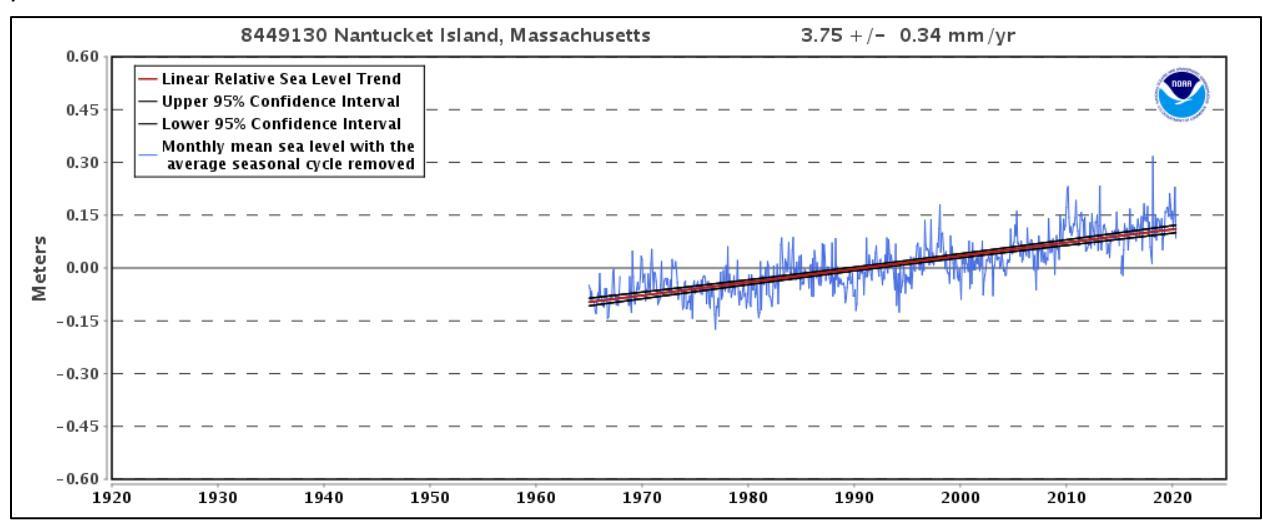
Figure 12, Nantucket's Relative Mean Sea-level the Trend Over Time

NOAA has been monitoring sea-levels on Nantucket for decades. Figure 12 shows the monthly mean sea-level and data collected since 1965. The change from 1965 to 2018 represents 1.21 feet in 100 years.
